Problems resulting from absent insulation

In one of the articles in the last edition of *Green Building* magazine Tony Cowling said that he would talk more about a family home that he visited during the DraughtBusters project. This home had lots of problems and his team returned there to undertake some thermal images of the problem areas. Here is what they found ...

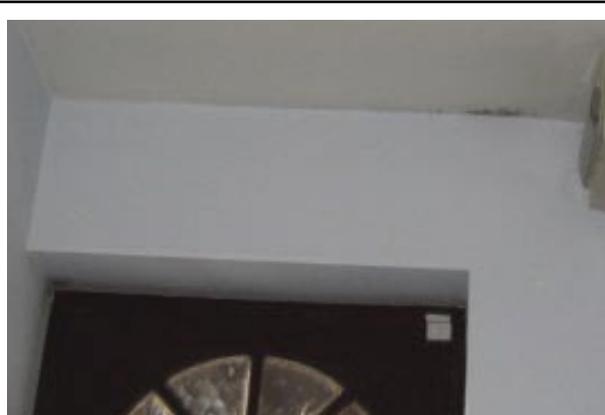
entering the property there was an external unheated large porch leading to the front door. Somewhat surprisingly there was evidence of both condensation and mould around the front door reveal and also at the wall ceiling junction, both of which were inside the porch and should have been slightly warmer (pictures 1 & 2). The damp on the ceiling was initially thought to be from a leaking shower, but above the front hallway there was only the third bedroom. The thermal image clearly shows cold bridging in the door reveal and highlights the area of mould at ceiling level as being very cold. We suspect that there is some missing cavity wall insulation at this point, possibly due to the presence of a damp tray and/or significant air leakage around joist ends.

Pictures 1 and 2, even though the door was within a porch there were cold spots around the door and at the ceiling wall junction.

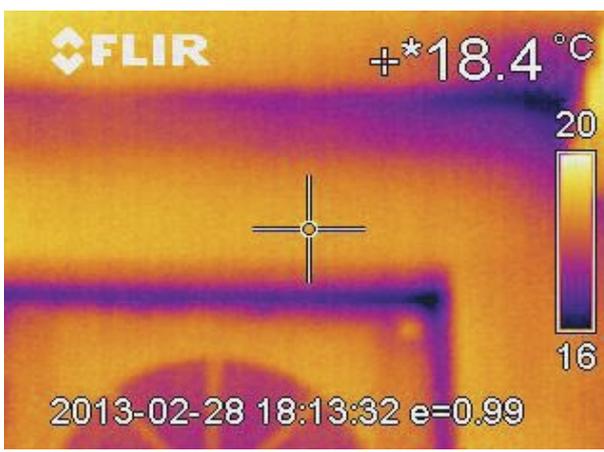
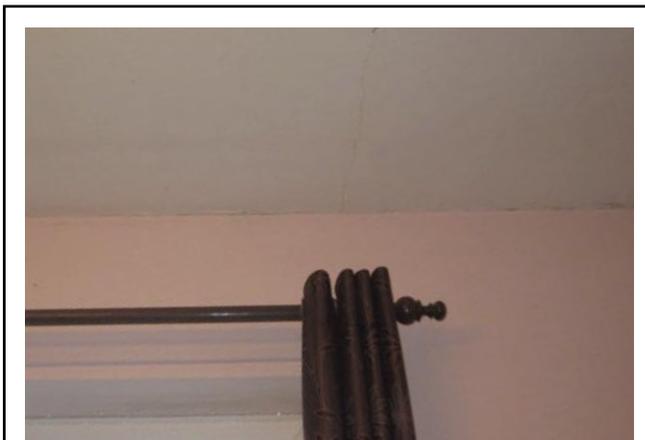
In the lounge there were several cold damp patches on the ceiling edges and the external corner was very cold (pictures 3 & 4). At skirting level it was very cold too and in places there was again evidence of condensation and mould (see pictures 5 & 6). The householders were good and dried washing outside and even cooked with the back door open. The corner of the room, at floor level, is shown in picture 7, with a thermal image in picture 8; there is a lot

Pictures 3 and 4 indicating cold spots at ceiling and wall junctions.

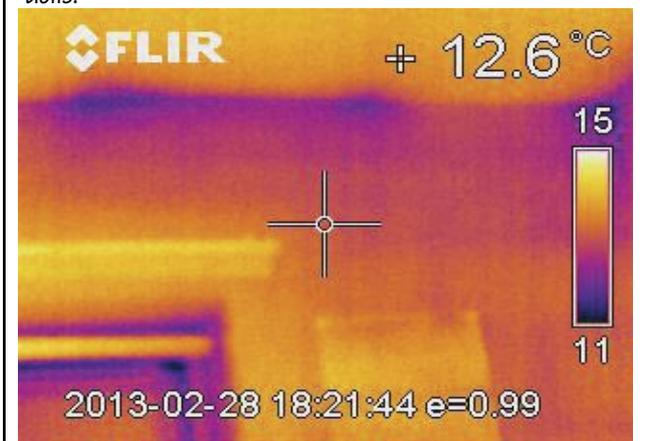
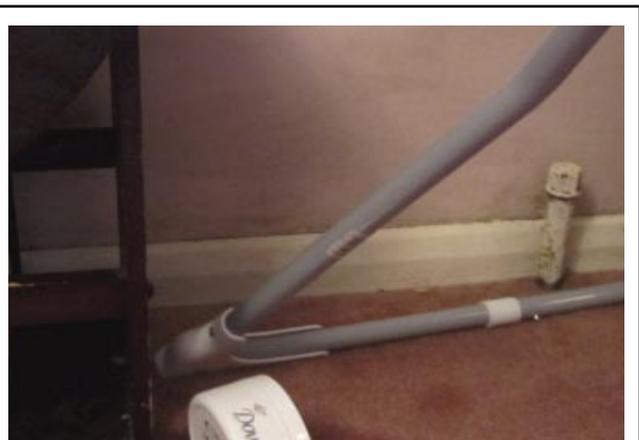
Pictures 5 and 6 show the same problem at the skirting boards. These cold spots cause condensation and then mould.

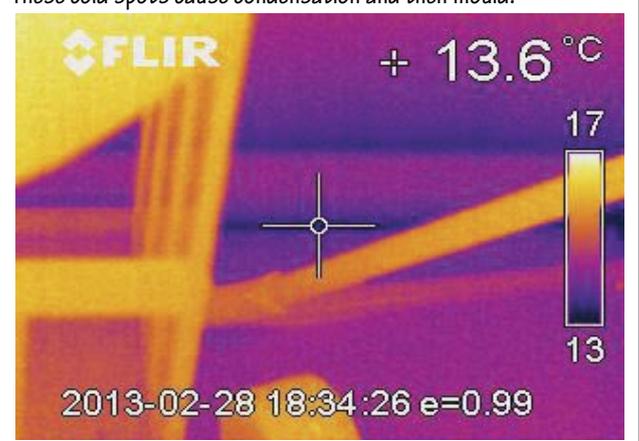
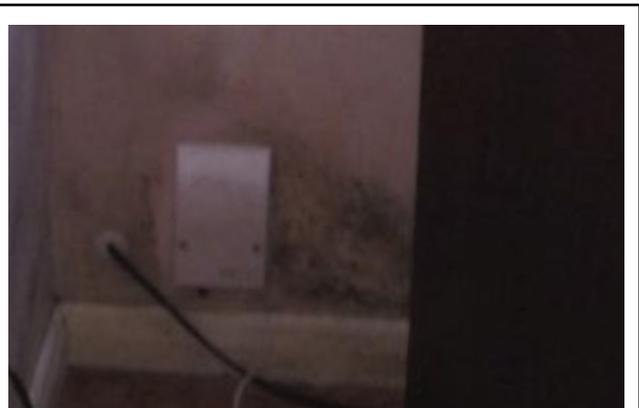
of cold coming in around the cable TV entry point, while the wall above the skirting was below dew point, seemingly a lot of the time. The family did admit that they could not afford to run the heating very often and they couldn't operate their thermostat as it seemed not to do anything.

Pictures 7 and 8 show that even socket entry points are cold spots. Corners are particularly vulnerable to mould growth.

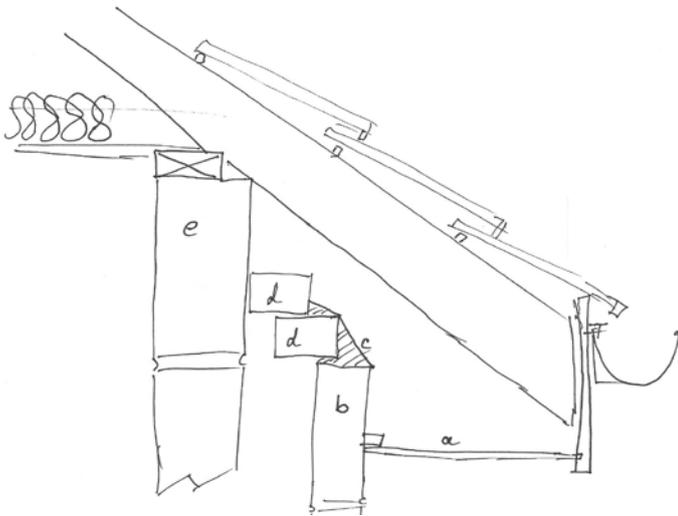
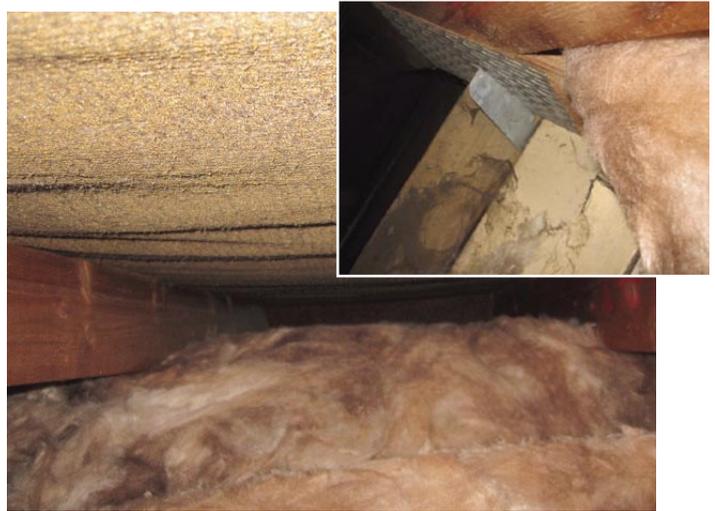
Picture 10 showing the old fashioned roofing felt with inset pic showing the lack of insulation at the eaves.

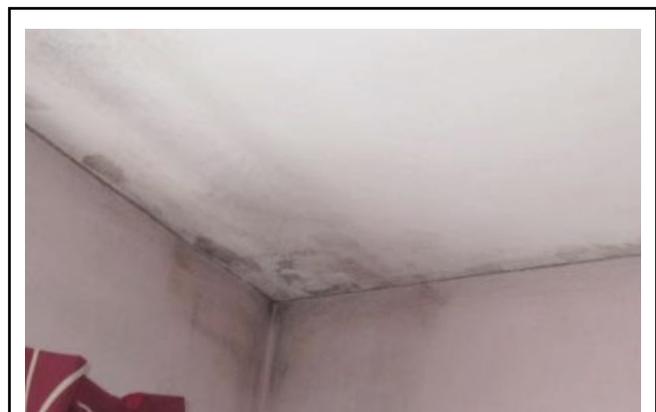
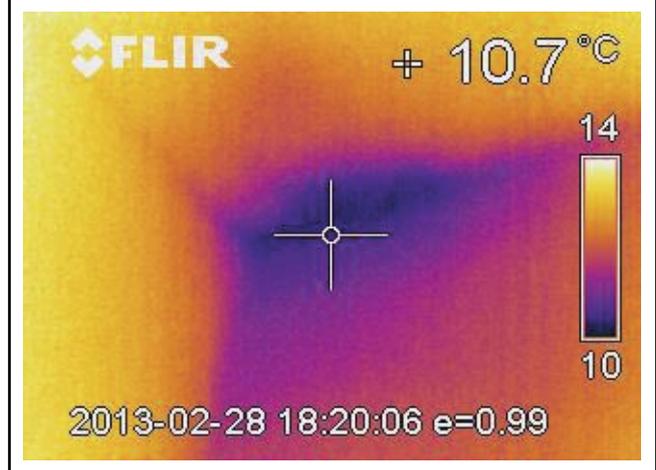
The main bedroom had problems around the top of the external walls and the ceiling edges, especially at the external corner. Picture 11 shows the condition; it looked much worse to the naked eye. From the thermal image it can be clearly seen that the top of the wall is much cooler than it is lower down, as it has no insulation at the top. It is also possible to see the thermal bridging effect of the mortar between the blocks, the darker lines in brick bond faintly visible in the thermal image (picture 12).

Pics 11 and 12 shows that the bedrooms beneath the roof space were really bad for condensation and mould at external corners

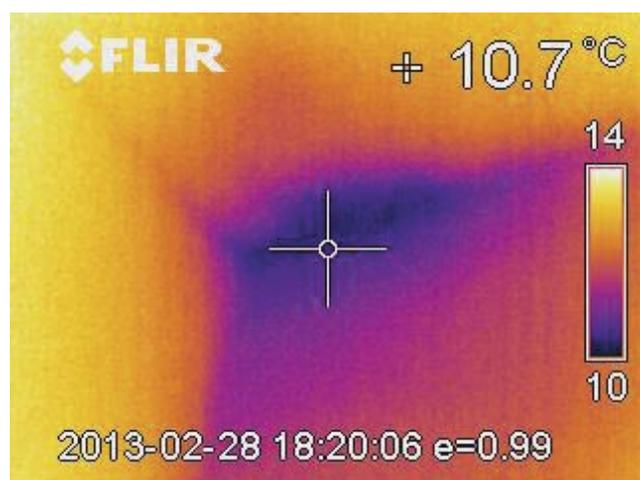
Picture 13 is a thermal image showing missing insulation at the ceiling edge, where an internal partition meets the external wall. Again there was mould growth exactly

matching the cold patch, and, of course, missing insulation to the edge of the ceiling. The causes of this can be seen in the picture above (inset) which shows the wallplate and ceiling edge. The clean patch on the ceiling is where I very slightly pulled back the insulation in order to take the photo. In my view the only way to insulate is before the roof sarking goes on. The process, therefore, is to build roof, affix a vapour/air tightness layer, tack ceiling, insulate, inspect for 'misses' and complete the insulation works over the wall plate area, leaving the required ventilation gap and

Picture 13 shows the heat loss where an internal partition meets the external wall.

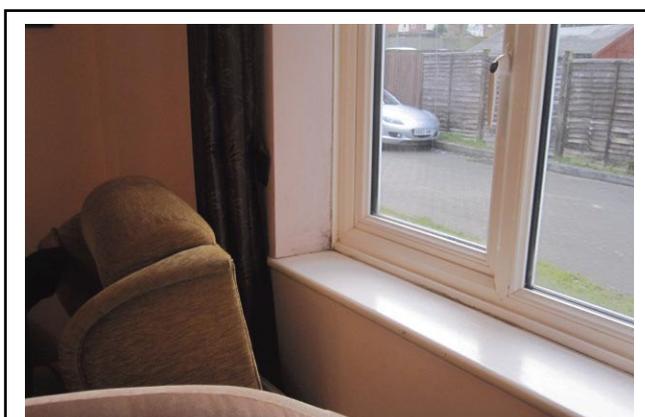
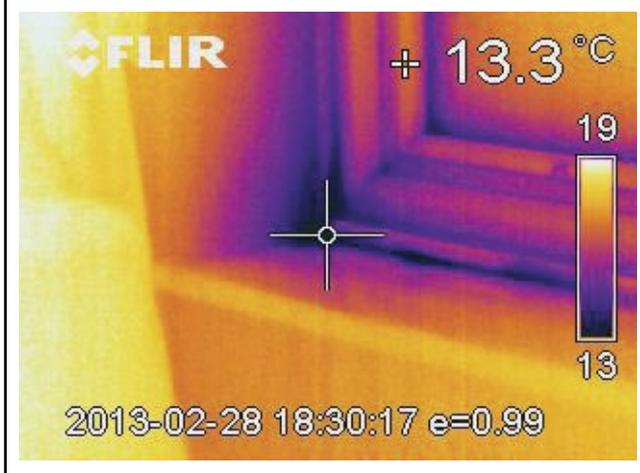
Pictures 14 and 15 showing the significant heat loss paths at the corners of the seemingly well insulated windows.

The window reveals had such bad thermal bridging immediately adjacent to the frames (pictures 14 and 15) that I removed a trim to satisfy myself that there weren't any gaps or cracks leading to outside. This showed that the windows had been generously siliconed in all around

with no gaps, quite a nice filling and covering up job. This led me to assume that silicone is a good conductor of heat (and condensation surface) compared to plaster, thus causing the cold spots and mould round the frames. Evidence here suggests that the more plaster that fell off, the more silicone went on and the more cold bridges and black mould resulted. Should the trims be removed, the silicone cut out and a more insulating filler be used?
