Problems resulting from absent insulation

In one of the articles in the last edition of *Green Building* magazine Tony Cowling said that he would talk more about a family home that he visited during the DraughtBusters project. This home had lots of problems and his team returned there to undertake some thermal images of the problem areas. Here is what they found ...

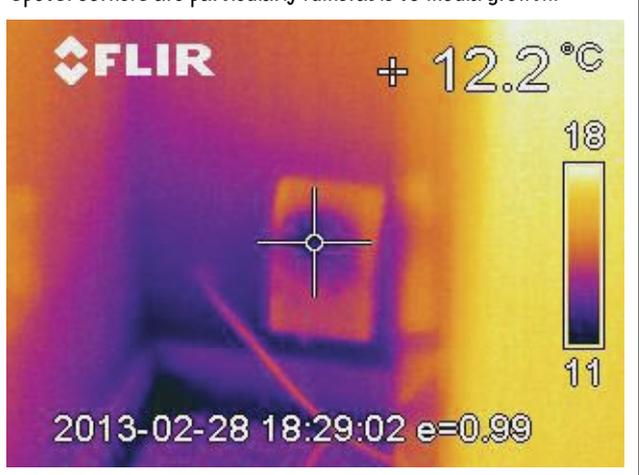
In the lounge there were several cold damp patches on the ceiling edges and the external corner was very cold (pictures 3 & 4). At skirting level it was very cold too and in places there was again evidence of condensation and mould (see pictures 5 & 6). The householders were good and dried washing outside and even cooked with the back door open. The corner of the room, at floor level, is shown in picture 7, with a thermal image in picture 8; there is a lot

Pictures 7 and 8 show that even socket entry points are cold spots. Corners are particularly vulnerable to mould growth.
